RE: Site Inspection; U. S. Energy, Frank M and Tony M Mines,
M/017/001 and S/017/017, Garfield County, Utah

Date of Inspection: January 29, 2004
Time of Inspection: 8:30 a.m. to 1:00 p.m.
Conditions: Mostly clear, 40's
Participants: Fred Craft (operator's representative), Jim Butt (reclamation contractor), Will Stokes (SITLA), Buzz Rakow (BLM), Paul Baker (DOGM)

**M/017/001 and S/017/017, Frank M and Tony M Mines, U. S. Energy
Inspection Dated: January 29, 2004; Report Dated: February 4, 2004**

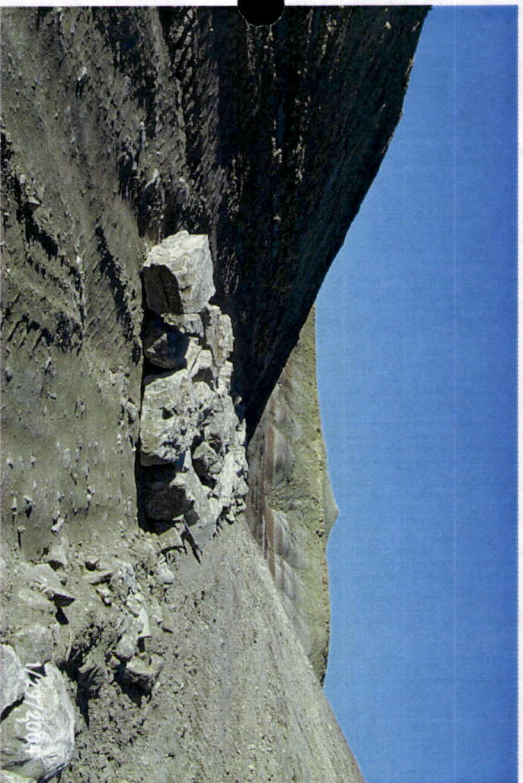
The road leading to the impoundment had been ripped and seeded. The dam was breached, and large rocks from the inside of the dam were placed on the first part of the resulting channel through the dam (Photo 1). A more traditional riprapped channel was created where this channel begins to drop more steeply (Photo 2).

breached, I believe it is unlikely the pond will discharge in the foreseeable future. If discharge was likely, I would be concerned about the lack of graded material in the channel through the breach. If there was flow, it would tend to erode the clay around the large rocks.

Photo 1. The breach in the dam for the mine water impoundment.

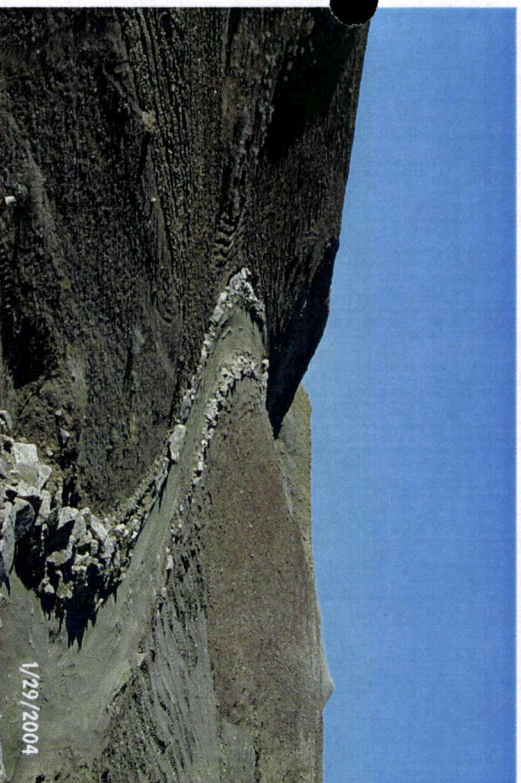
Photo 2. Channel leading down from the breach shown in Photo 1.

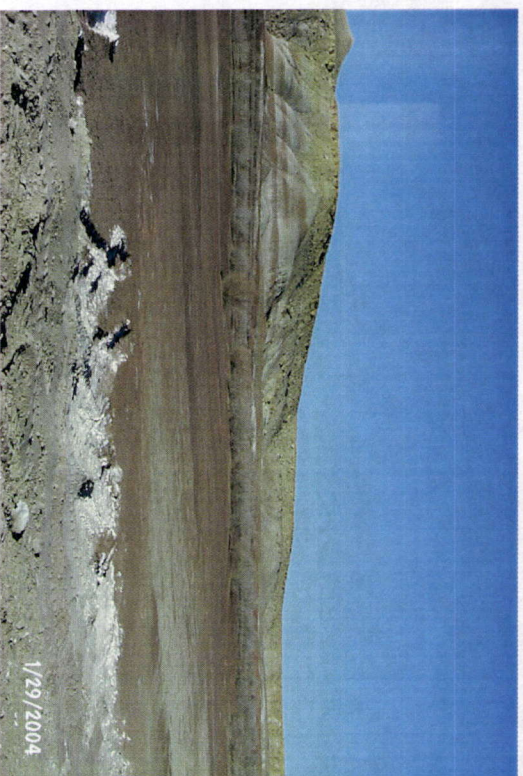
The pond area itself (Photo 3) had not held appreciable water in several years. There was no vegetation in the pond, but there were tamarisks growing around the edges. The watershed that drains into the pond is about 58 acres.

There is very little vegetation on the clay slopes around the pond, so from a vegetation standpoint, I am not concerned about the lack of vegetation in the bottom of the pond. The Division should, however, obtain copies of analyses of the pond sediment and ensure it is not potentially deleterious.

Photo 3. The mine water impoundment. The trees near the old water line are tamarisks.

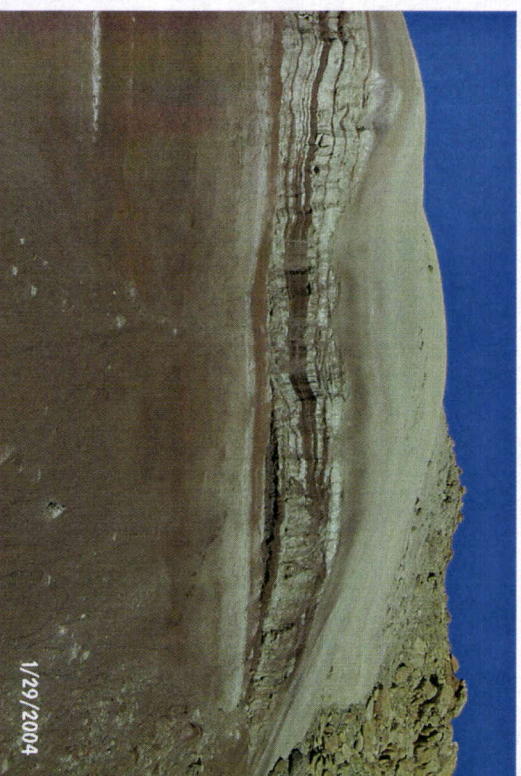
During operations, water was piped from the mine to the pond through a pipeline laid in a cut on the clay slopes above the impoundment (Photo 4). The operator did not backfill this cut and does not intend to do so. We hiked up to this area to view it more closely, and although the cut looks large from below, a lot of material has sloughed into it (Photo 5). There is not much of a cut left, and over time, it will probably disappear altogether.

Photo 4. The cut on the hill above the mine water impoundment. The water line used to be in this cut.

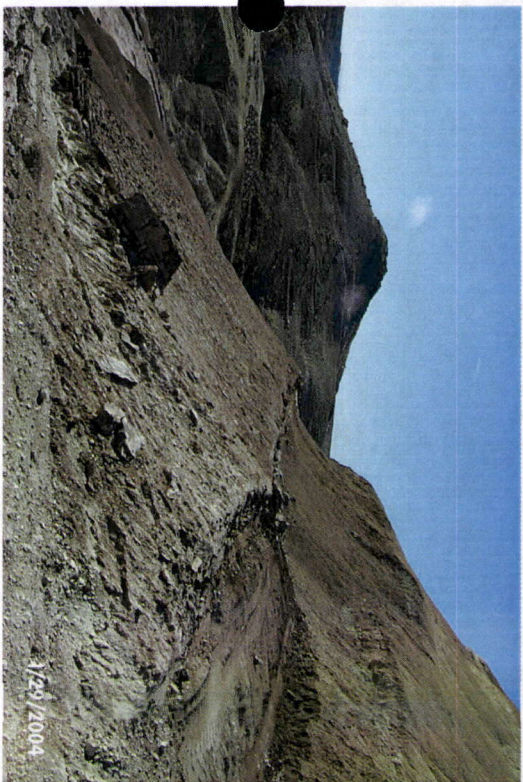
Photo 5. Cut where the water line used to be. Note how the cut is healing.

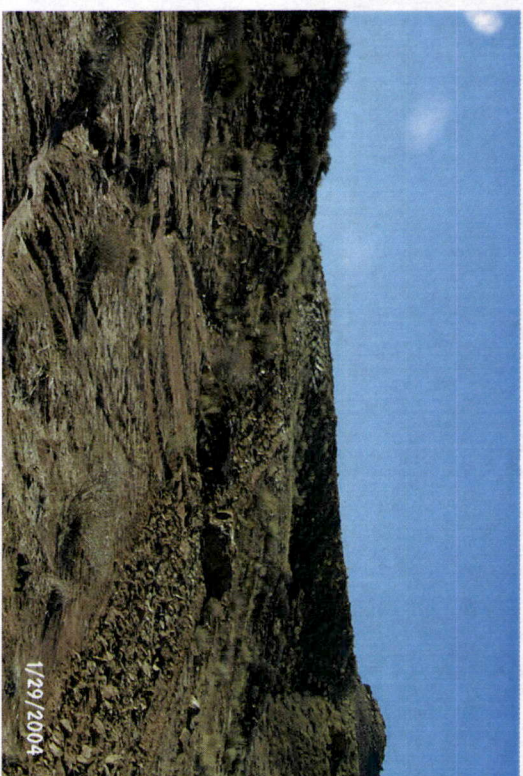
All of the vent holes were reclaimed in a similar manner, although there was some variation. The same technique was used at the Velvet Mine in San Juan county. I did not actually see how the holes were capped, but Mr. Butt had documented the process in photographs. He showed us pictures of each site. A plate was first welded to the casing in the shaft. Next, a collar was placed around the top of the shaft. This collar has a diameter a few feet larger than the shaft and was intended to hold the concrete. Reinforcing steel was then placed inside the collar. In all cases but one, the reinforcing steel included rebar and small I-beams. Rebar alone was used at one of the holes with a smaller diameter (six inches?). Concrete was then poured into each of these shafts, and the whole thing was covered with about four feet of soil. These sites were all graded so it is essentially impossible to tell anything was there (Photo 6). The access roads and the pads were all roughened to promote water retention, infiltration, and plant growth (Photo 7). The operator has blocked most of the reclaimed roads with large rocks.

Photo 7. Road leading to one of the vent holes. Note how the road was ripped and roughened, and also note the large rocks in the roadway.

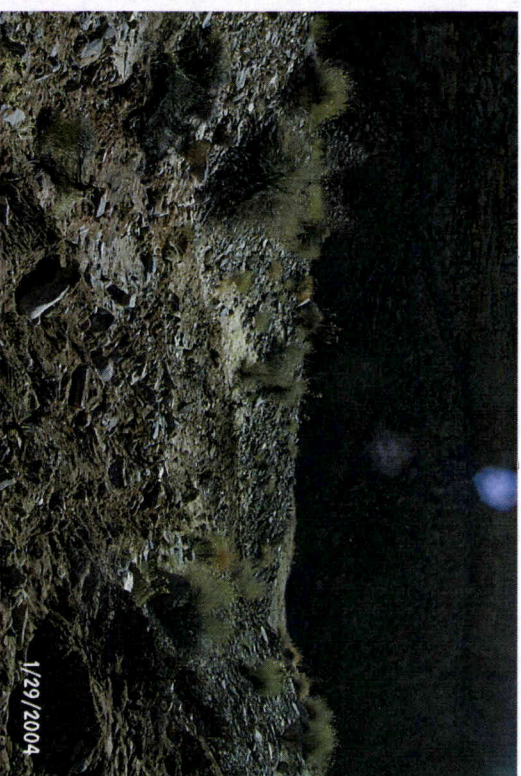
We next went to the emergency escape. Part of this area had not been ripped, and Mr. Butt said he would bring equipment back to rip it. The short access road had banks on either side (Photo 8), and the way the site was configured, most runoff from the pad would be channeled to the road where there

Photo 8. Road leading to the escapeway.

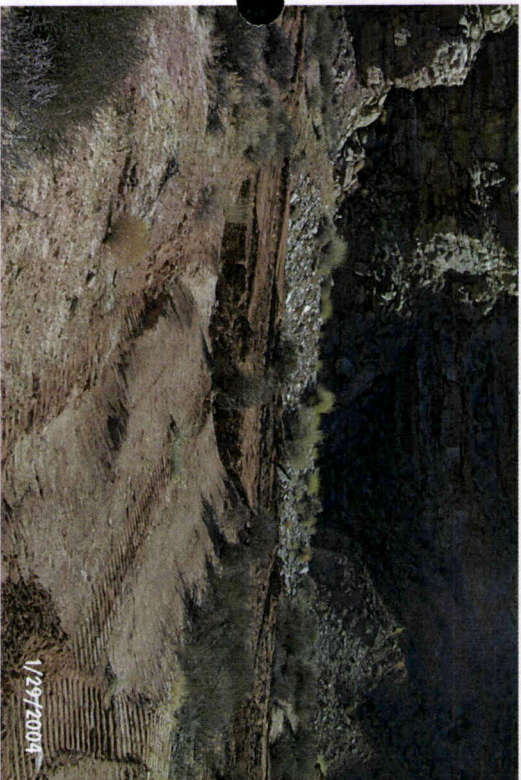
could be some erosion problems. During an inspection in November, the operator was advised to put a berm at the top of the road to direct water to the side and away from the road. This had been done (Photo 9).

Photo 9. Near the center of this picture is a berm that directs water away from the road leading to the escapeway.

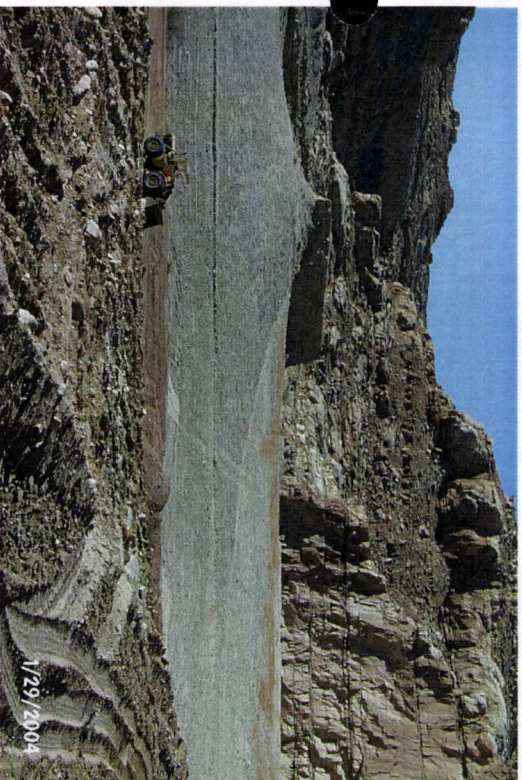
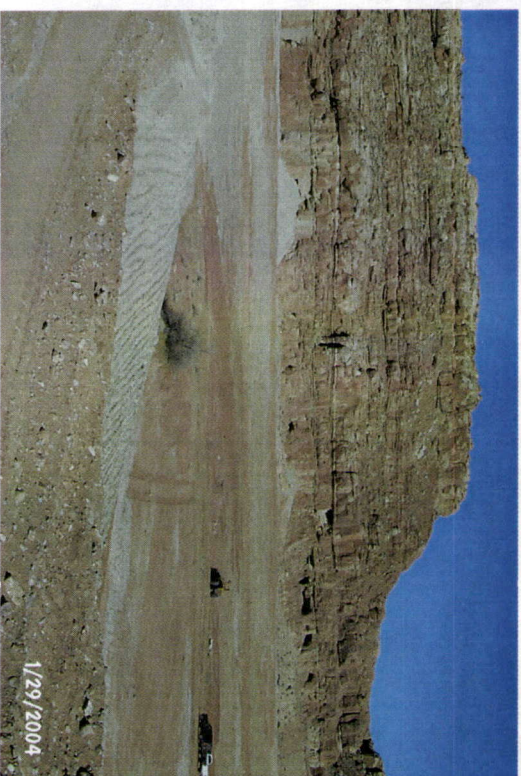
Ore and waste in the main part of the mine had been graded, but there was still some surface preparation and seeding that needed to be done. Views of some of these areas are in Photos 10 through 13. Except for the main waste area shown in Photos 10 and 11, these areas were simply graded and roughened in preparation for seeding.

The waste pile in front of the main mine area (Photos 10 and 11) was graded so there are three terraces. The uppermost of these was the mine pad, and it was being ripped during the inspection. Runoff from above the mine would be caught on this terrace and channeled toward the south. Mr. Craft indicated water would then go into some abandoned portals. The other terraces are designed to decrease the slope length, and one takes water to the north and the other to the south.

Material used as soil varies from very sandy to somewhat clayey. Probably the least desirable substitute soil is in the waste pile at the main mine area. It appears to be a clayey sand or sandy clay. The test plots shown in Photos 14 and 15 are probably a good representation of the potential vegetation cover in the area, and it may be possible to use them as a success standard.

Photo 10. Waste pile at the main mine area. Note the terraces.

Photo 11. Another view of the waste pile at the main mine area.

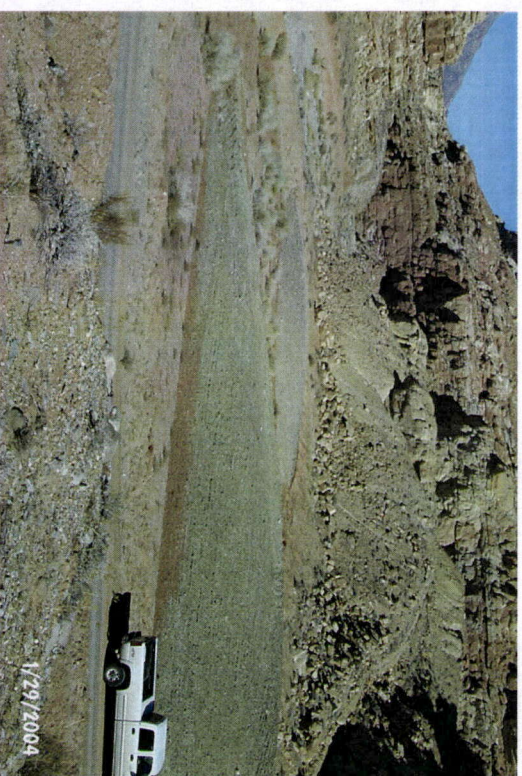
Photo 12. Two ore piles up canyon from the main mine area.

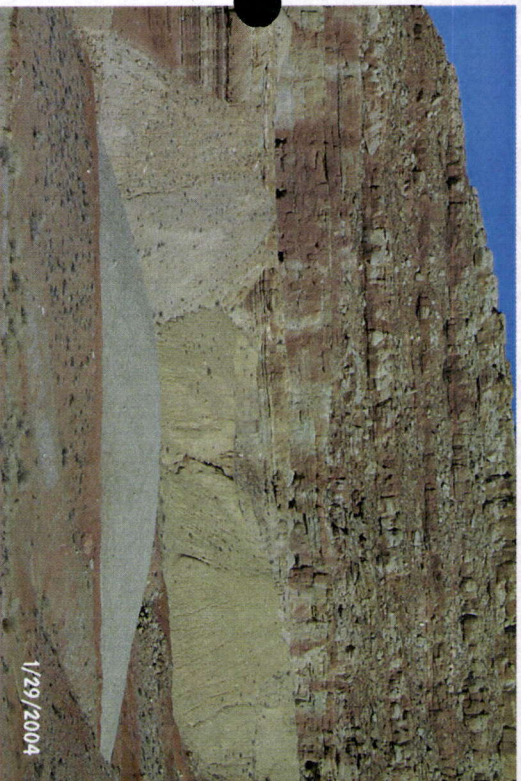
Photo 13. An ore pile down canyon from the main mine area.
Note also the abandoned adits and waste piles in the canyon wall above the ore pile.

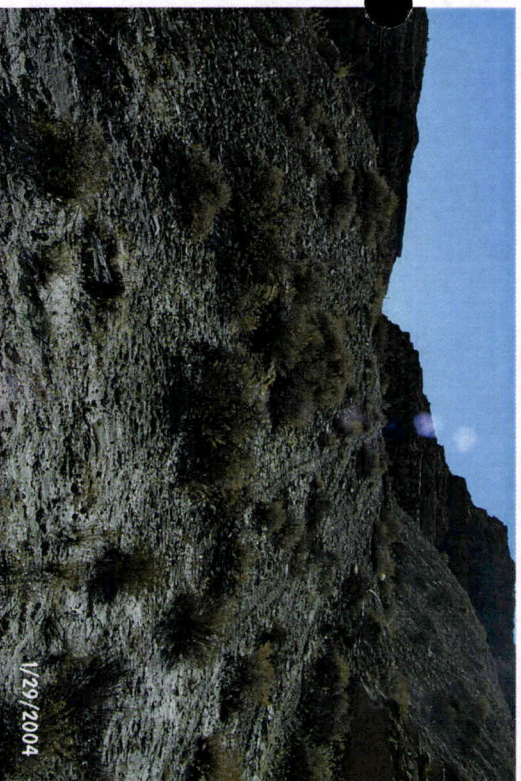
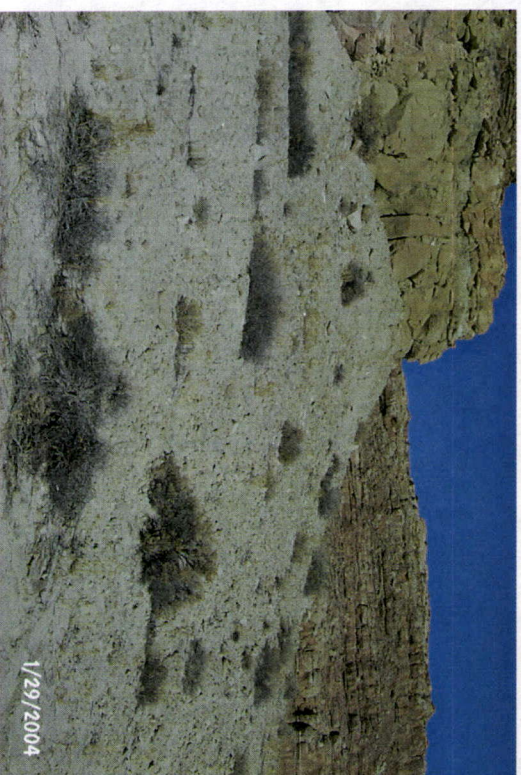
The operator had test plots that I understand were marked with metal posts. These posts have been removed. The test plots are shown in Photos 14 and 15.

Photo 14. One of the revegetation test plots.

Photo 15. Another revegetation test plot.

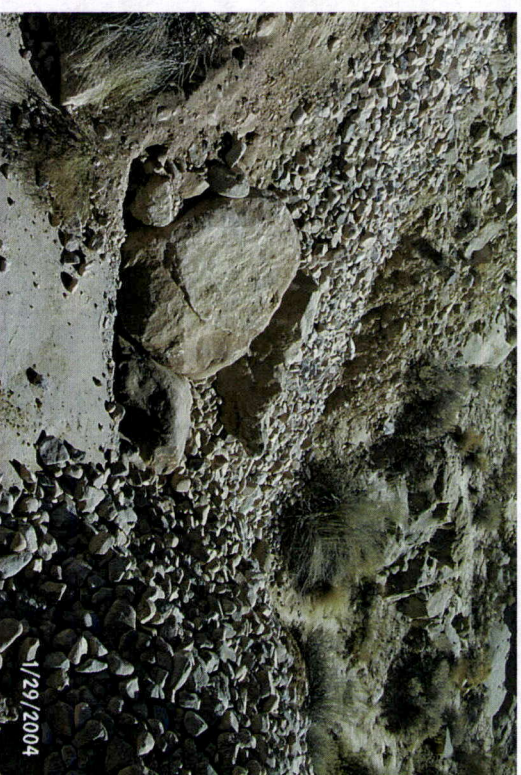
On the south side of the main mine area is an access road with a culvert that will remain. During last November's inspection, the Division asked the operator to put some rock or riprap material on the downstream side of the culvert to reduce head cutting. This has been done (Photo 16). In this same area, there was a powder magazine that has been reclaimed.

Photo 16. Rock placed on the downstream side of a culvert that will not be removed.
